Project Management Challenge Conference

The Challenges Encountered and Overcome During the Development of the Space Shuttle Orbiter Boom Sensor System (OBSS)

March 2006

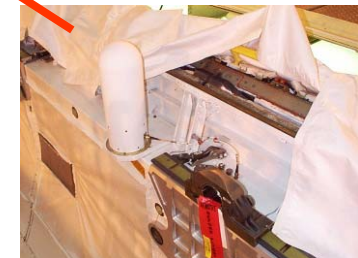
WVS UHF Antenna
Before Location

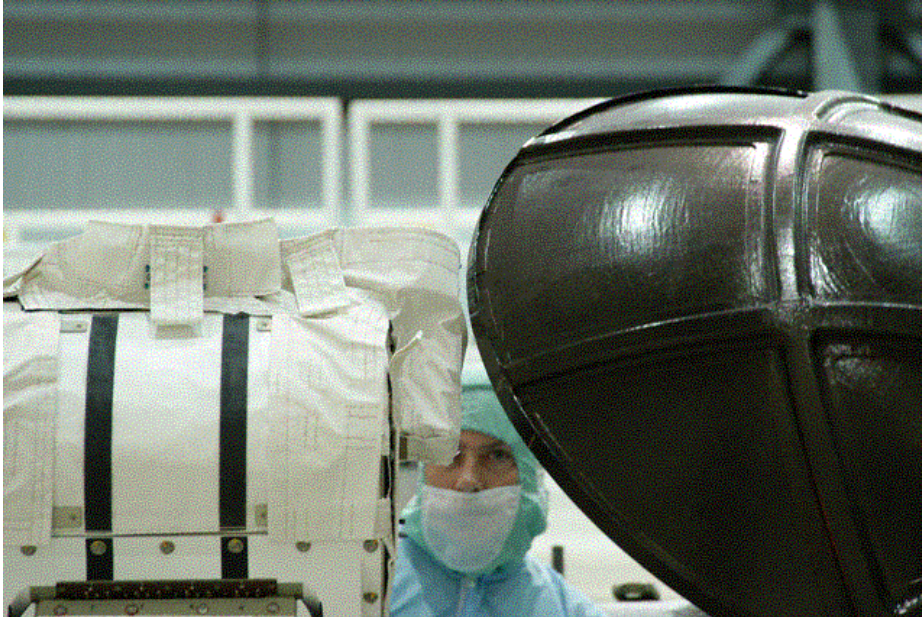
Clearance Issues

KU band antenna clearance with boom
